# Identifying Corrosion

Understanding the type of corrosion activity on a vessel is the most crucial step in providing an effective solution and prevent further corrosion activity.

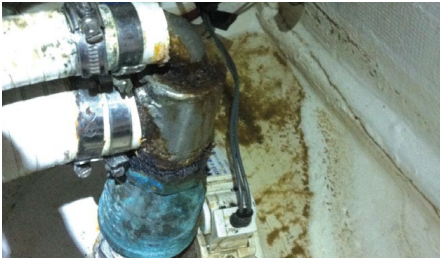
## Galvanic Coupling

Dissimilar metals exposed to the same electrolyte (water) makes a galvanic coupling and galvanic corrosion.

**Solution: Ensure all fittings are of the same material, or bond to an anode for cathodic protection.**

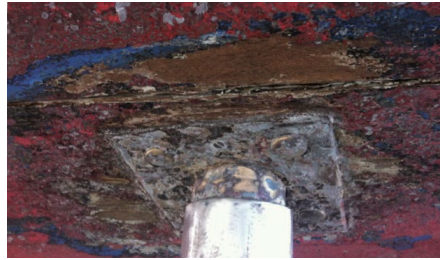
## Alkaline Degradation

Wood rot caused by overprotection from anodes destroying the cellulose fibres in wood.

**Solution: Install only Maddox Anode™ on timber vessels where anode protection is required.**

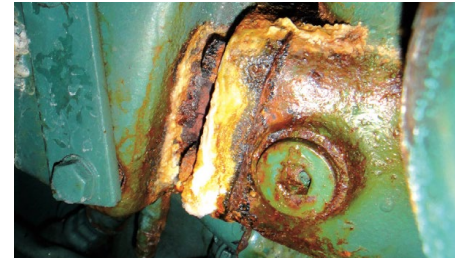
## Engine Components

Most often caused by stray current from an engine or on board electrical component. Common causes - lack of galvanic isolation, alternators, battery chargers and more.

**Solution: Seek professional assistance.**

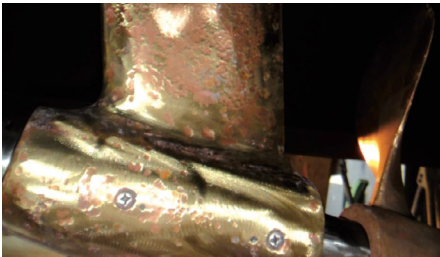
## Dezincification - Pinking

Bronze is a composite alloy metal. When not properly connected to an anode, the alloy will leach from the bronze and leaving it weak, brittle and pink.

**Solution: Improve bonding/connection to an appropriate anode.**

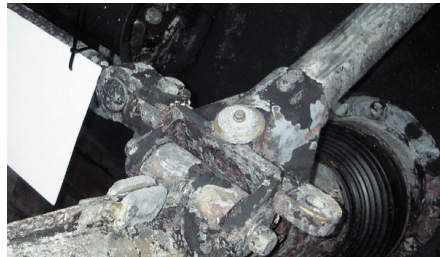
## Paint Blasting

Most commonly seen on stainless steel trim tabs, swim platforms or marlin board supports. Caused by over protection.

**Solution: See Anode Selection Guide and seek professional assistance for best protection levels.**

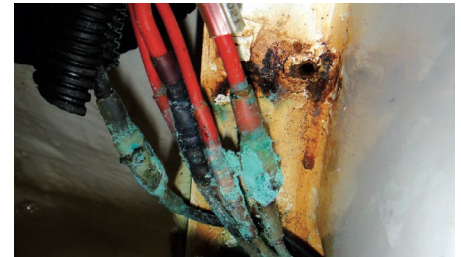
## Poor Bonding / Electrical

A common problem - . Insufficient wire size, not tinned or fine strand, localized corrosion & poor connections result in high resistance & poor conductivity.

**Solution: See our Bonding Guide & Seek professional assistance.**

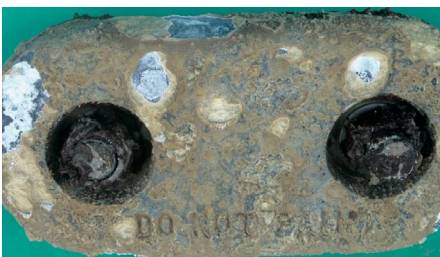
## Zinc Passivation

Zinc anodes can build up a crusty layer over the metal as a natural form of oxidation defense. This is usually caused by changes in current draw on the anode or environmental influences.

**Solution: Ensure correct anode type installed. See Anode Selection Guide.**

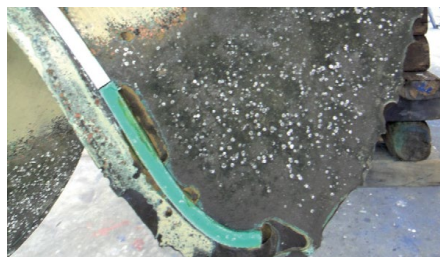
## Electrolysis Submerged

Caused by DC stray currents from on board electronics, faulty wiring or from marina stray current if no galvanic isolation is installed.

**Solution: Seek professional advice.**

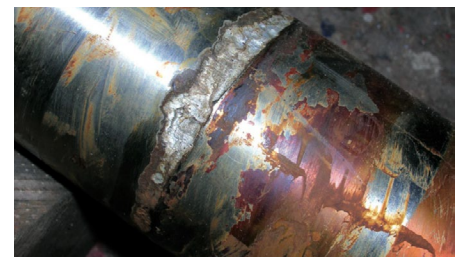
## Atrolytic - Worm Corrosion

Commonly affects stainless steel components where water becomes trapped (stern tube, threads, pipes) - becomes highly acidic and destroys the stainless steels protectant layer. Can be exacerbated by overprotection or indifference between surfaces.
